Access Report on Entrances and Facilities at Brecon Cathedral

24 May 2022

JANE TOPLIS ASSOCIATES LTD

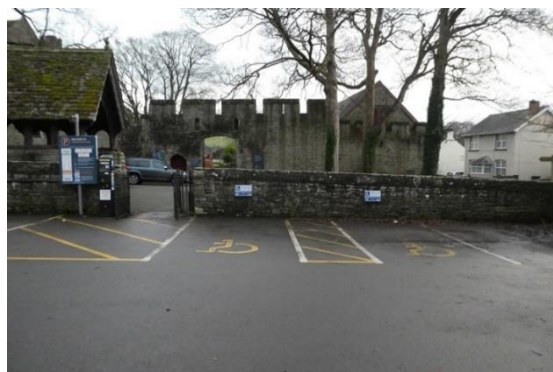
The public car park, located to the north west of the Cathedral is where many tourist visitors park. This public car park is not managed by the Cathedral. It has two designated accessible parking bays. A level gateway opens into the Cathedral driveway in front of the Lych Gate.

Designated accessible parking bays in public car park with gateway leading to Lych Gate

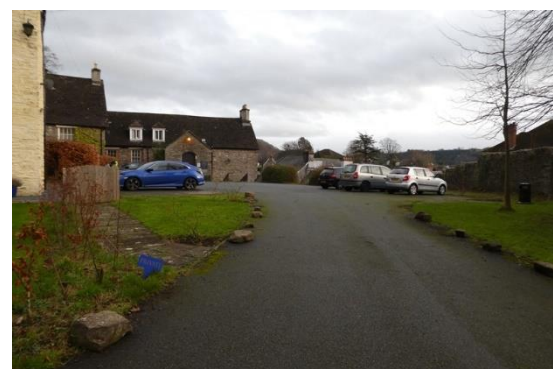
The Cathedral car park is located to the south of the Vestry and Deanery Range. Public parking is not permitted here, except for specific visitors and disabled people who have made advance contact with the Cathedral. There are no designated bays marked out.

Cathedral car park where disabled visitors can pre-book a parking place

- *In the short term, if a disabled driver wishes to visit the Cathedral, a management procedure should be established to ensure that there is sufficient transfer. These transfer zones can be denoted by placing traffic cones to indicate a level space large enough to transfer out of the car at the side or rear of the parking bay.*

- *In the long term designated accessible parking bays with transfer zones should be marked out in a suitable location within the Cathedral Close.*

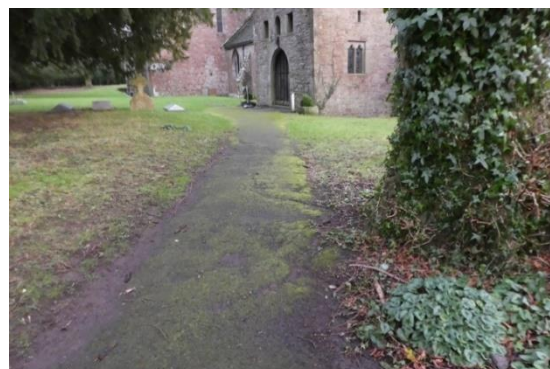
This entrance is often used by first time visitors to the Cathedral, arriving and parking in the public car park. A tarmac path runs through the churchyard from the Lych Gate to the North Porch, which has an uneven surface in a poor state of repair.

Uneven path from Lych Gate to North Porch

- *Resurface tarmac path through churchyard so that there is a smooth surface.*
- *In the short term the contrasting nosings on some steps should be repainted.*
- *In their current arrangement the North Porch steps present a trip hazard for ambulant disabled and visually impaired people, due to their irregular dimensions and the low lighting levels. A design study is required to see if there are any possible locations to mount handrails, taking into account the confined space within the porch and the steps' proximity to the door swings.*

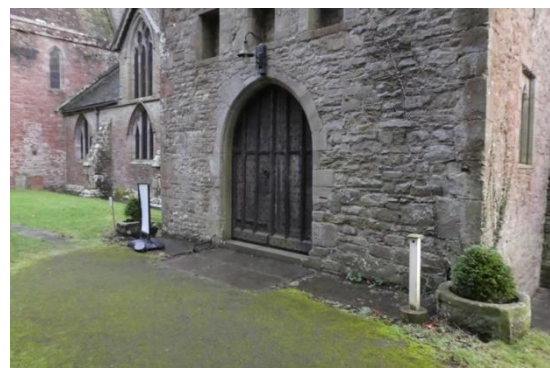
In detail the porch has a 125mm high step up to the external double doors (860mm clear width). Just inside these doors there are two steps (risers of 150mm and 170mm height) down into the porch.

Approach to North Porch and 125mm step at double doors

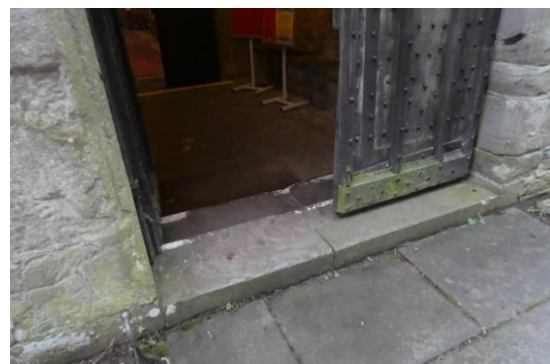
None of the porch steps have handrails and the painted contrasting nosings on some steps are worn away.

Outer double doors, with a raised threshold with one step up and two steps down inside

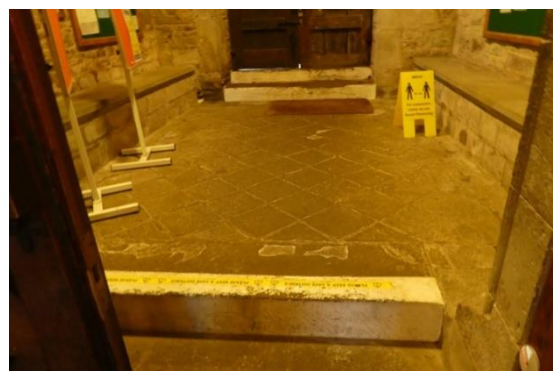
View from inner double doors towards two steps up to outer double doors

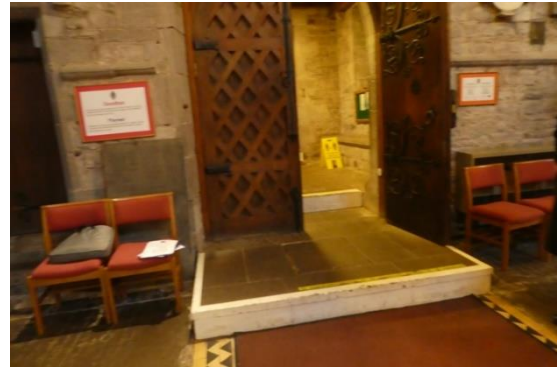
These inner double doors open into the Cathedral Nave over an approx. 1.8m wide stone platform, which steps down another 200mm to Nave floor level.

1800mm wide stone platform in front of the inner double doors from the porch

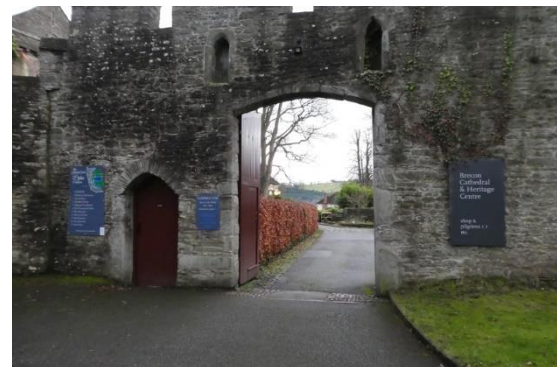
Vehicle gate on entry into the Cathedral Close

The pedestrian route through the vehicle gateway into the Cathedral Close is busy with pedestrians approaching the Tythe Barn café from the public car park, but it has no segregation between vehicles and pedestrians. A smooth area of tarmac surface has been installed at the gateway, where there had been an uneven cobble strip. This provides a smooth surface for wheelchair users.

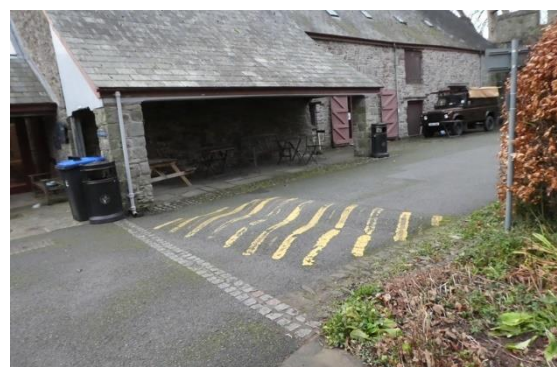
Narrow smooth strip on far side of speed bump in the Cathedral Close is too narrow for easy wheelchair circulation

The route to the wheelchair entrance continues to a speed bump across the pedestrian/vehicle driveway. There is a narrow level section at one end of the speed bump, running alongside a cobble strip, which is not quite wide enough for wheelchair users to easily negotiate along.

- *The speed bump needs to be altered so that there is a wider smooth route past it, from the Cathedral Close gateway to reach the accessible entrance and Cathedral car park, where disabled drivers are permitted to park.*
- *In the long term the external surfacing within the Cathedral Close should be adapted and pedestrian and vehicle routes more clearly defined.*

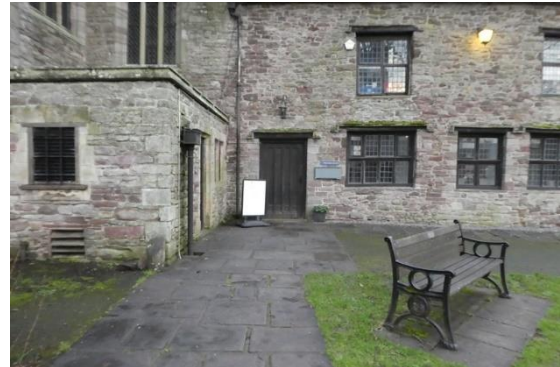
Just beyond the speed bump there is a reasonably level flagstone path to the South Door into the Vestry Range. This is a level doorway with 1050mm clear width. The door is heavy to push/ pull and the ironmongery is difficult for somebody with limited dexterity to open.

Flagstone path to accessible door into vestry range

- *In the short term the South Door into the Vestry should have its door closer adjusted to reduce the opening force in accordance with AD M 3.10a.*
- *In the short term handrails should be mounted on the two steps in the Vestry and more visible contrasting nosing strips are required on the step edges.*

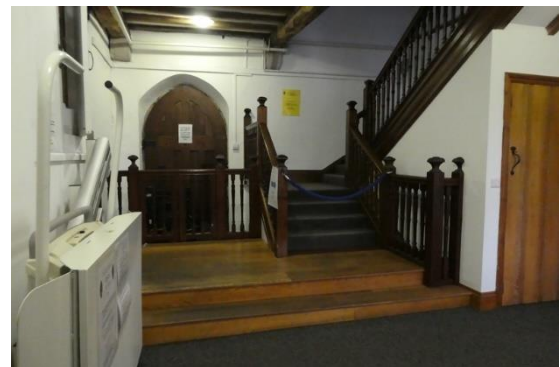
Inside this doorway there is a reasonable spacious level area and then two steps up to a small landing at Nave level. These two steps (130mm risers and 290mm goings) have no handrails.

An incline platform lift has been installed to rise up these two steps. A member of staff must be summoned to operate it, so it is not an unassisted means of access.

Double doors, with 860mm through one opening leaf and 125mm step up

Wheelchair users find incline platform lifts awkward and undignified to use. Many people will refuse to use them. They are also slow and can often break down. This is not an acceptable accessible entrance route into the Cathedral, especially as wheelchair users have to take a long detour from the main North Porch entrance. While on site I was informed that it is very rarely used.

- *A design study is required to establish the best location for an inclusive accessible entrance (for able bodied people and wheelchair users) into the Cathedral, avoiding the awkward steps at the North Porch entrance and the very poor wheelchair route into the Cathedral through the Vestry Range. Section 3 discusses different entrance options.*

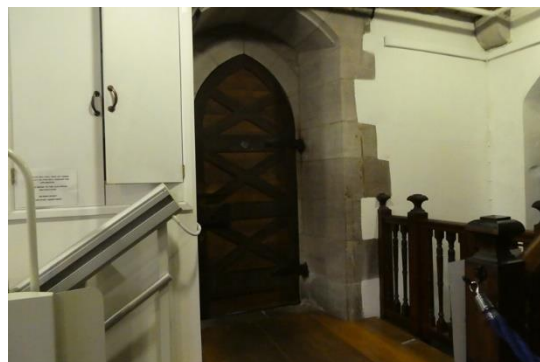
The final access barrier on the 'wheelchair accessible' route is the door from the Vestry Range into the Cathedral's South Aisle. The door (860mm clear width) is approached from the narrow landing at the top of the two steps discussed in section 2.1.5 above. It is positioned within a deep alcove through a thick wall. The offset at the leading edge of the door leaf is less than the required 300mm and the wheelchair manoeuvring space is constricted by the top step edge, the metal track of the incline platform lift and a balustrade.

South Aisle Door has no space for a wheelchair user to manoeuvre and open the door independently

The door is either left open when the Cathedral is open to the public, or staff have to open it for a wheelchair user to pass through, because of this lack of manoeuvring space.

- *The South Aisle Door opening from Vestry Range should be automated, or the doorway widened. This door is discussed in Section 3 Option 11.*

Option 11 (South Aisle Door enlarged opening) The South Aisle door is narrow and is positioned within a thick wall without any offset at the leading edge. It is currently either left open when the Cathedral is open to the public, or staff have to open it for a wheelchair user to pass through. By widening this doorway, it would make it easier for a wheelchair to enter from the vestry unassisted. An alternative to widening the door opening is to automate the door, but the noise of the door opening may be a disturbance during a service or event.

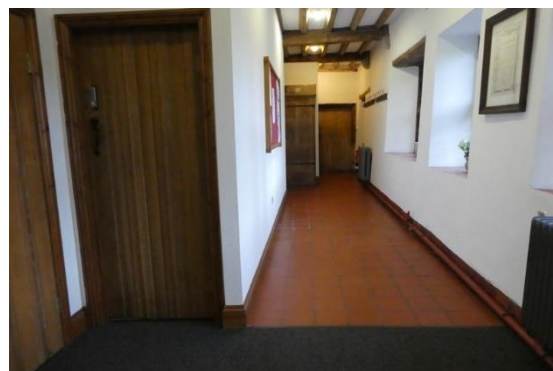
These facilities are reached from the Cathedral by descending the two steps in the Vestry lobby. Alternatively a wheelchair user has to descend using the incline platform lift to the level corridor leading to the WCs.

Corridor to WCs in Vestry Wing

- *Due to the fact that the incline platform lift will be removed once an alternative accessible entrance to the Cathedral is implemented, there will need to be an accessible route from the Cathedral to the WCs. A ramp is required to link the South Aisle door*

from the Nave to the corridor at WC level. Installing a ramp here may require the alteration of the two steps and landing to provide a wheelchair width level route to reach the top of the proposed ramp. A design study will be required to establish the best adaptation in this area.

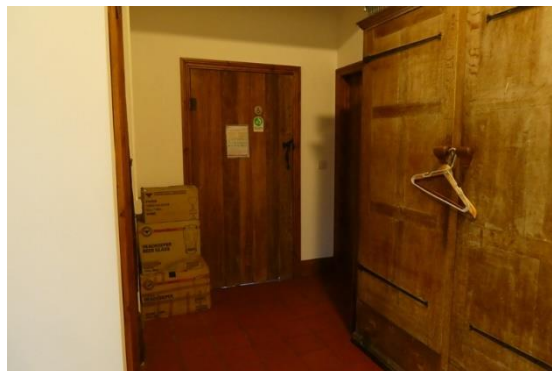
The unisex wheelchair accessible WC cubicle is reached from a reasonably wide lobby area and has an outward opening door (980mm clear width). The large cupboard in the lobby slightly obstructs wheelchair circulation in front of the WC door.

- The wheelchair symbol on the door is too small and is mounted at high very level. The baby changing symbol mounted just below it is more visible.
- The wrought-iron ironmongery on the door is not openable by someone with limited dexterity and is at very high level (1325mm afl) with a small pull handle below it. The requirement is that door ironmongery should

Approach to accessible WC door is obstructed by cupboard and has small high sign

- *The door signs on the unisex wheelchair accessible WC cubicle door should be larger to assist people with vision impairments, and mounted at maximum 1200mm height suitable for wheelchair users.*
- *The wrought-iron door ironmongery should be replaced with door handles at 900mm afl. The door handles and controls should be able to be operated with a clenched fist and the door should be openable from the outside, if somebody falls within the cubicle.*
- *A horizontal grabrail should be fixed on the inner face of the door at 900mm afl.*
- *The baby changing unit should be mounted at 850mm afl.*

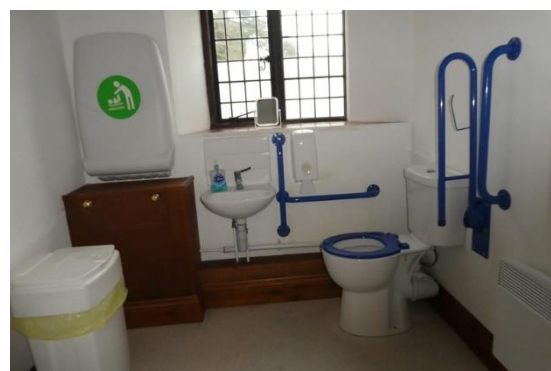
The internal cubicle size is 2090mm long and 2081mm wide, so it does not quite meet to the access standards set out in Building Regulations AD M (2200mm x 1500mm cubicle size). It also contains a baby changing facility. Given that the cubicle is wider than the minimum required dimension, it is my opinion it is an acceptable size cubicle for a unisex wheelchair accessible WC.

The arrangement of WC pan, wash basin and most of the grabrails meet the current access standards, taking into account it is inserted into an existing historic building. There is good visual contrast between the WC pan seat and grabrails, against the white walls.

Interior of unisex wheelchair accessible WC cubicle

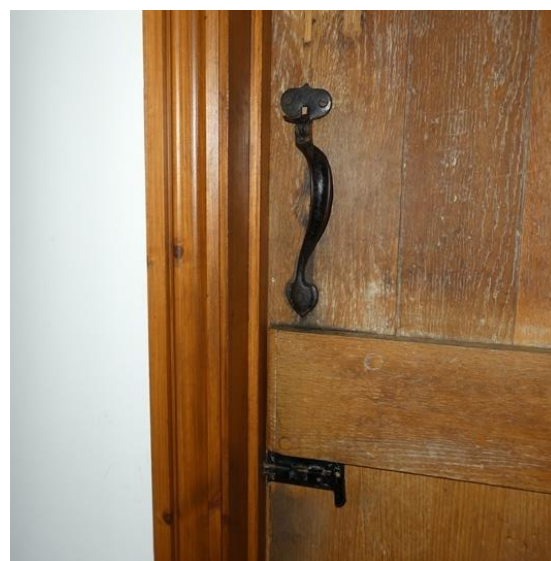
Door ironmongery is not openable by someone with limited dexterity

be able to be operated by someone using a clenched fist. Inside there is a small, awkward sliding bolt to secure the door. This bolt is mounted at a reasonable height (945mm afl) but cannot be opened from the outside, if somebody falls within the cubicle.

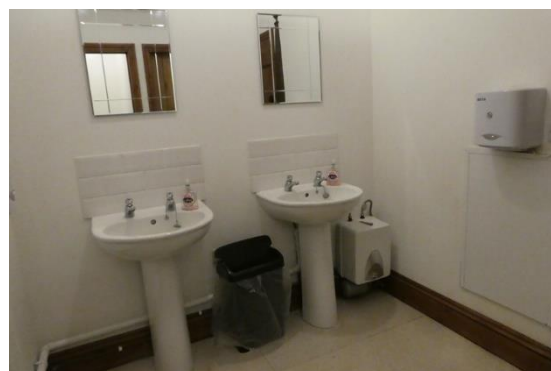
Within the men's and women's WCs there are no ambulant disabled cubicles with grabrails and outward opening doors. The internal décor provides no visual contrast between the white sanitary fittings and the background tiles and walls.

Internal décor provides no visual contrast between white fittings and walls

- *One cubicle in both the men's and women's WCs should be adapted to be an ambulant disabled cubicle.*
- *When the WCs are next decorated, there should be better visual contrast between the doors, walls and floors to assist people with vision impairments.*
