OLIVER ARCHITECTURE

BRECON CATHEDRAL : OPTIONS APPRAISAL MATRIX FOR IMPROVED ACCESS INTO CATHEDRAL

MAY 2022, version v.3

Note: This document has been prepared following the public consultation event on 9th April 2022. A number of options were discussed during the event and several more raised informally afterwards. The purpose of the document is to establish a way of appraising the merits of the various options. For each option, a series of comments on appropriate topics are noted, with a summary of LOW, MEDIUM or HIGH. A LOW summary may of course mean a poor outcome, a low financial cost option or a low impact on heritage, so it may be good or bad. All entrances to the Cathedral are considered, starting at the North Transept and working anti-clockwise to the South Aisle. Part M of the Building Regulations defines the lengths and pitch of a ramp. Revised following input from Jane Toplis Associates Ltd, access consultant.

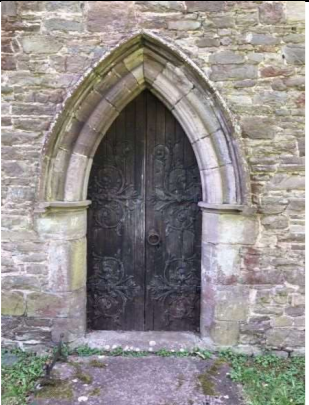
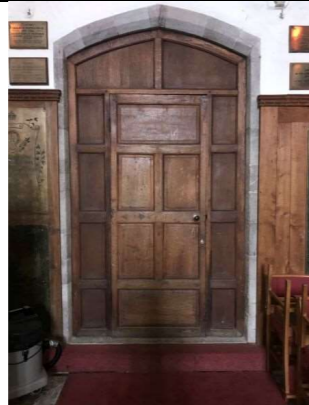
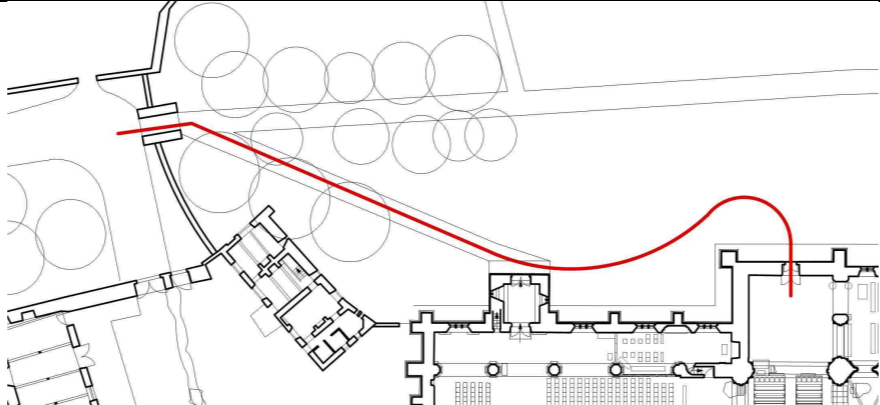
Ref.	Name	Description	Universal Access from North	Universal Access from South	Access to WCs	Impact on Heritage	Functionality	Cost	Other Benefits		
1	North Transept Door <i>(Peter Jenkins and Dannatt Johnson 'Option 2')</i>	From the car park and lych gate, use the existing path (resurfaced to avoid uneven surfaces) to the North Porch, with a new path to the North Transept, gently pitched to the slightly raised threshold. New ramp within North Transept down to floor level.	Provides access for wheelchair users, but able bodied users would continue to use existing doors, so wheelchair users are separated and use a lesser door. Score = LOW	No improvement. Score = LOW	Improvements from South Door down to Accessible WC will be needed, as proposed for many options. Score = MEDIUM	Minimal impact. Score = LOW	Very poor, as delivers wheelchair users too far east inside the Cathedral. Score = LOW	Landscaping but otherwise relatively modest. Score = LOW	None noted.

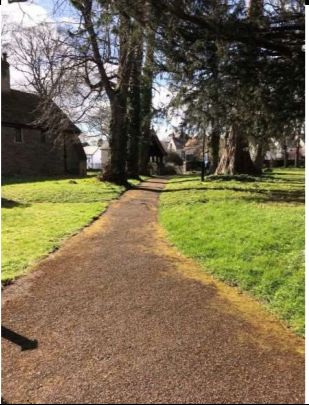
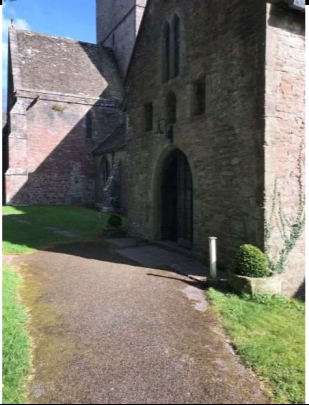
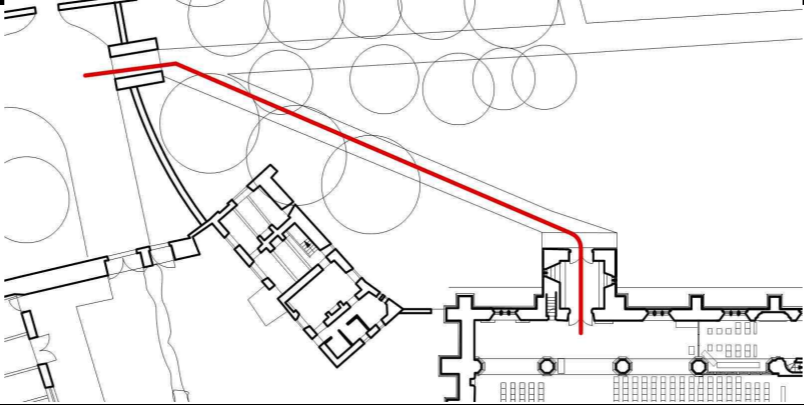
2	North Porch lowered pathway <i>(Peter Jenkins and Dannatt Johnson 'Option 1')</i>	From the Lych Gate, excavate to lower the pathway so that it gradually arrives at internal floor level outside the North Porch (less steep than a ramp). Lower the floor in the North Porch. Alter the doorways to suit.	Both wheelchair users and able bodied users will be able to use this route, but it is a long way from the car park. Score = MEDIUM	No improvement. Score = LOW	Improvements from South Door down to Accessible WC will be needed, as proposed for many options. Score = MEDIUM	Major impact on both the North Porch, its historic joinery, and archaeology within the churchyard. Score = HIGH	Arrival at the west end of the church is suitable. However, there will be difficulties in underpinning the Porch and diverting rainwater from running into the building. Score = LOW	Major cost for underpinning and archaeology. Score = HIGH	Potential for new glazed joinery to encourage visitors.

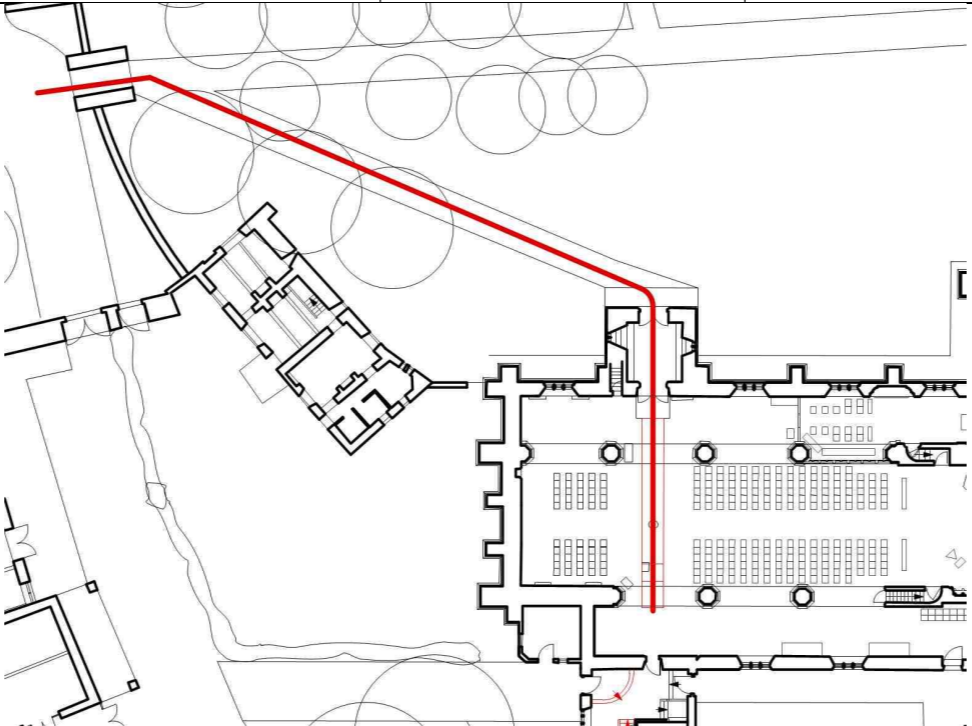
3	North Porch raised floor and ramp	During the event, a suggestion was made to raise the floor level within the Porch to that of the external ground level and then create a ramp within the Nave or North Aisle. This would be a 10m long ramp (the maximum permitted), with a landing and then a further 1.8m ramp. It would reach to the South Aisle. This is why options to explore ramps within the Porch itself were explored.	Both wheelchair users and able bodied users will be able to use this route, although ramps are less suitable for some users, but it is a long way from the car park and the length of ramps is excessive. There is no alternative stepped route. Score = MEDIUM	No improvement. Score = LOW	Improvements from South Door down to Accessible WC will be needed, as proposed for many options. Score = MEDIUM	Major impact on the appearance of the interior of the Cathedral and the Porch. Score = HIGH	Arrival at the west end of the church is suitable. However, the extent of the ramp will reduce the functionality of the interior. Score = LOW	Alterations to Porch joinery and floor, new ramps. Score = HIGH	Potential for new glazed joinery to encourage visitors.

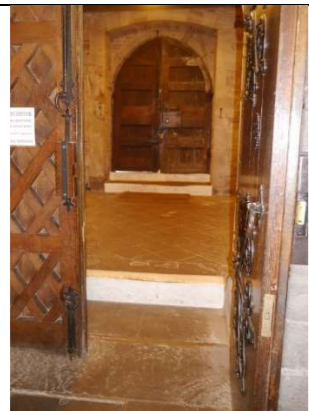
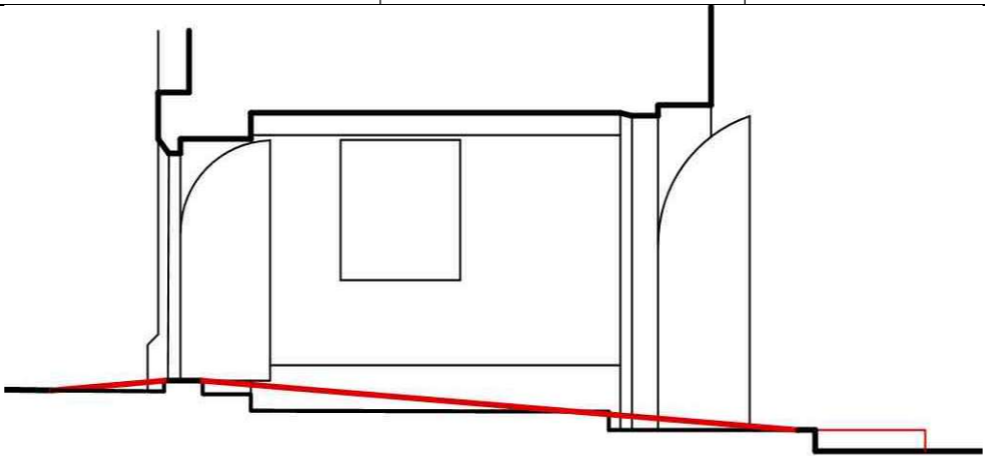
4	North Porch internal ramp	A short ramp up to the North Porch threshold, then a ramp down inside the Porch. A further short ramp inside the North Aisle.	Both wheelchair users and able bodied users will be able to use this route, although ramps are less suitable for some users. Level landings will be required. There is no alternative stepped route. Score = LOW	No improvement. Score = LOW	Improvements from South Door down to Accessible WC will be needed, as proposed for many options. Score = MEDIUM	Impact on the interior of the North Porch and lesser impact on interior of North Aisle. Alterations needed to C19 inner doors.	Arrival at the west end of the church is suitable. Little impact on functionality at west end.	Alterations to Porch joinery and floor, new ramps. Score = MEDIUM	Potential for new glazed joinery to encourage visitors.

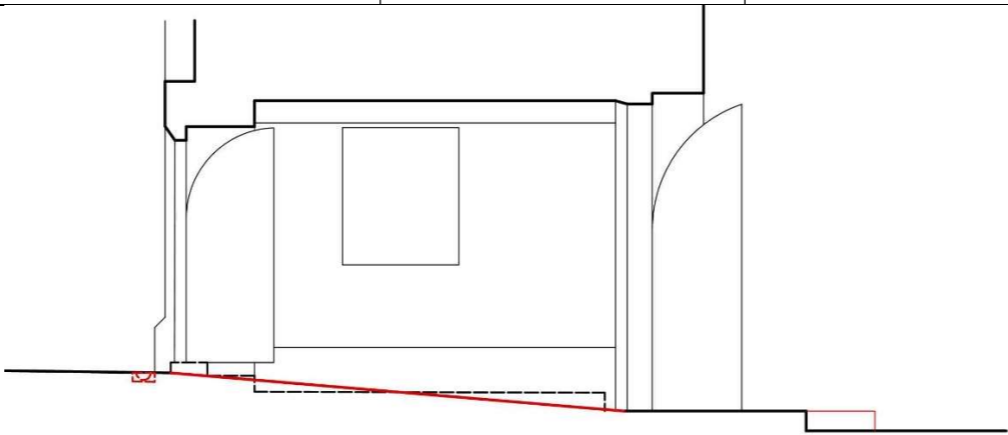
5	North Porch internal ramp with lowered threshold	Removal of the North Porch outer door threshold, then ramping the floor of the North Porch. A further short ramp within the North Aisle.	Both wheelchair users and able bodied users will be able to use this route, although ramps are less suitable for some users. Level landings will be required. There is no alternative stepped route. Score = LOW	No improvement. Score = LOW	Improvements from South Door down to Accessible WC will be needed, as proposed for many options. Score = MEDIUM	Impact on the interior of the North Porch and lesser impact on interior of North Aisle. Alterations needed to medieval outer doors. Score = MEDIUM	Arrival at the west end of the church is suitable. Little impact on functionality at west end. External rainwater will need to be diverted. Score = HIGH	Alterations to Porch joinery and floor, new ramps. Score = MEDIUM	Potential for new glazed joinery to encourage visitors.

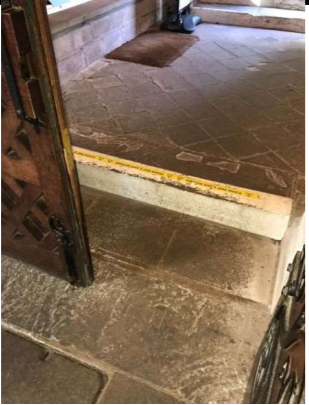
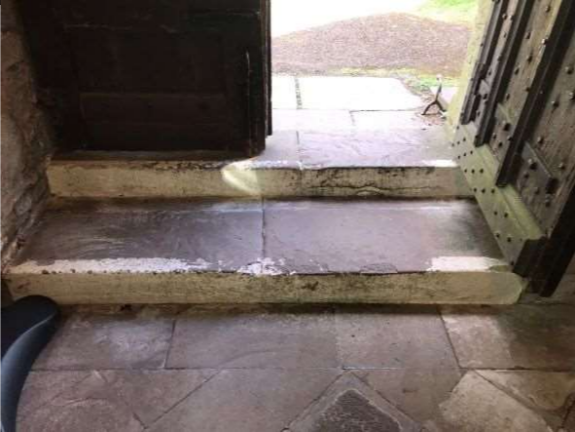
6	North Porch handrail <i>NB: A short term improvement, which does not intend to resolve the question of wheelchair access.</i>	During the event, it was noted that the existing arrangement is unsafe. The provision of a central handrail in the North Porch and into the North Aisle	Improvement for less able bodied but not for wheelchair users.	No improvement.	Improvements will need to be in a later phase.	Minor impact only.	Arrival at the west end of the church is suitable. Funerals will have to carry	Relatively low cost.	This option achieves a short-term benefit only. However, it could protect from litigation.

would assist less able bodied visitors. Lighting should be made brighter. Steps should be better marked.

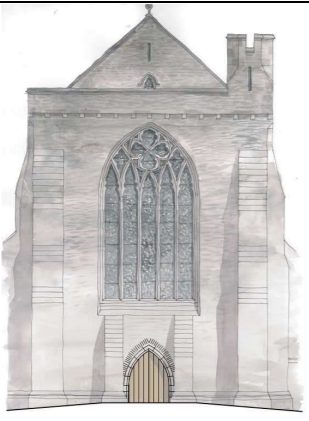
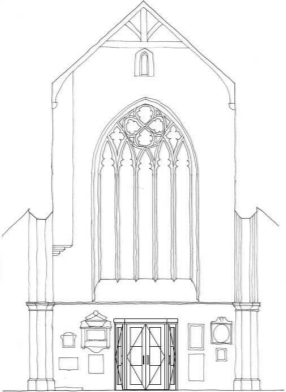
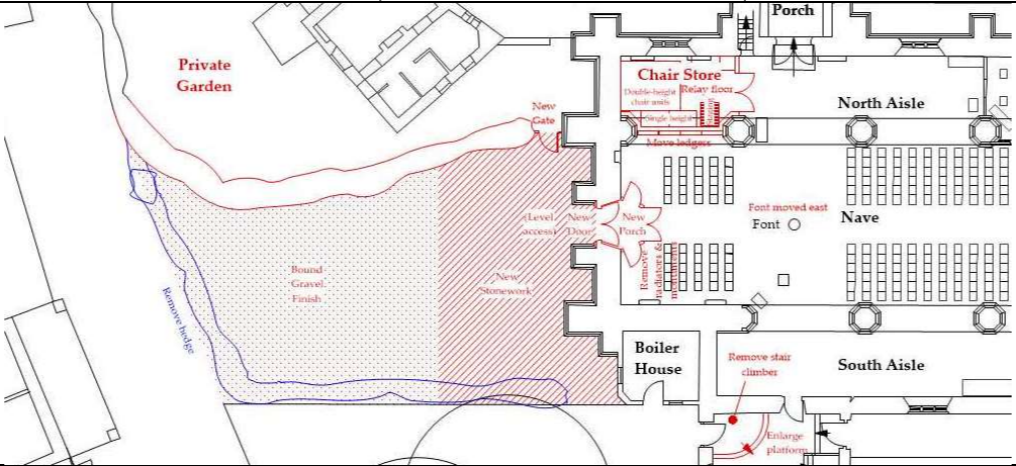
coffins above the handrail.		
7	New West Door	Alterations to the area west of the Nave to create a shallow pitched access to a new doorway with draught lobby inside.	Both wheelchair users and able bodied users will be able to use this route, which is equidistant between the north and south approaches. Score = HIGH	Both wheelchair users and able bodied users will be able to use this route. Score = HIGH	Improvements from South Door down to Accessible WC will be needed, as proposed for many options. Score = MEDIUM	Loss of C14th masonry between buttresses, but this is accepted in principle by both Cadw and local authority. Score = HIGH	Arrival at the west end of the church is suitable. Comments were made during the event about loss of raked seating during performances but this impact is minimal and would be offset by improvements to seating and staging at the Crossing. Score = HIGH	External landscaping, forming new opening, relocating memorials and draught lobby. The only option which has been costed by the QS includes other items such as chair store. Score = MEDIUM	Axial approach makes this entrance easier to find for new visitors. Creation of external space. Connections with the Tithe Barn.

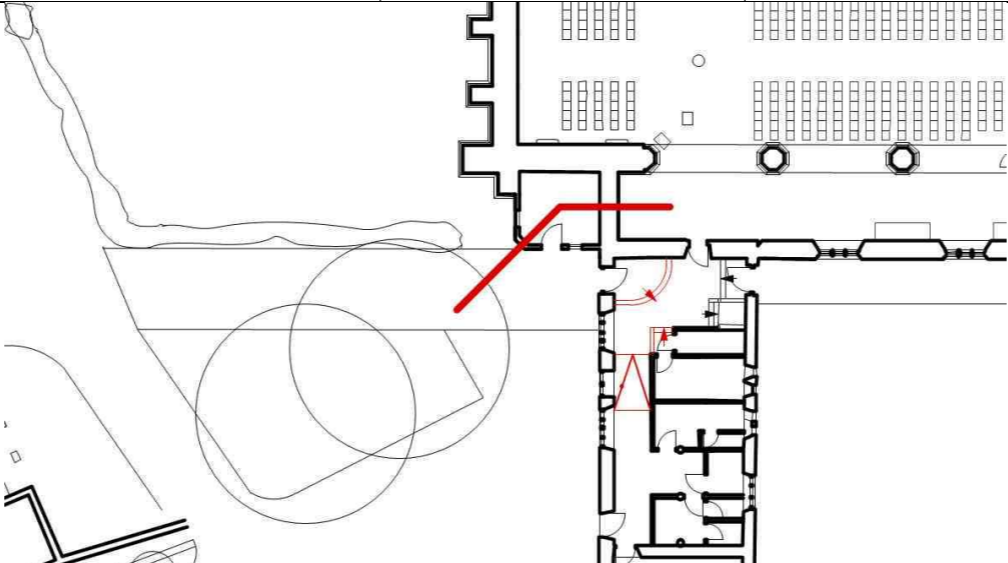
8	Boiler House <i>(Paul Woods's suggestion)</i>	Rebuild the Boiler House to form entrance to the Cathedral, relocating heating system elsewhere.	Both wheelchair users and able bodied users will be able to use this route, which is only slightly closer to those	Both wheelchair users and able bodied users will be able to use this route, which is only slightly closer to	Improvements from South Door down to Accessible WC will be needed, as	Loss of 1940 boiler house has no negative impact. Loss of	Arrival at the west end of the church is suitable. Loss	Construction of a new entrance, external	Opportunity to address the question of heating in relation

Ref.	Name	Description	Universal Access from North	Universal Access from South	Access to WCs	Impact on Heritage	Functionality	Cost	Other Benefits
		Regrade external levels to provide universal access. Form a new opening under the South Aisle west window.	approaching from the north. A new ramp or platform lift would be needed inside the new build. Score = LOW	those approaching from the north. A new ramp or platform lift would be needed inside the new build. Score = LOW	proposed for many options. Score = MEDIUM	C14th South Aisle masonry below window. Score = HIGH	of childrens' corner (west end of South Aisle) has vetoed this option in the past. Score = MEDIUM	landscaping and heating alterations makes this a very expensive option. Score =HIGH	to carbon which will need to be addressed soon. Opportunity to design a welcoming entrance.

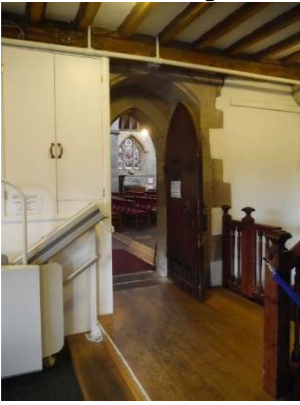
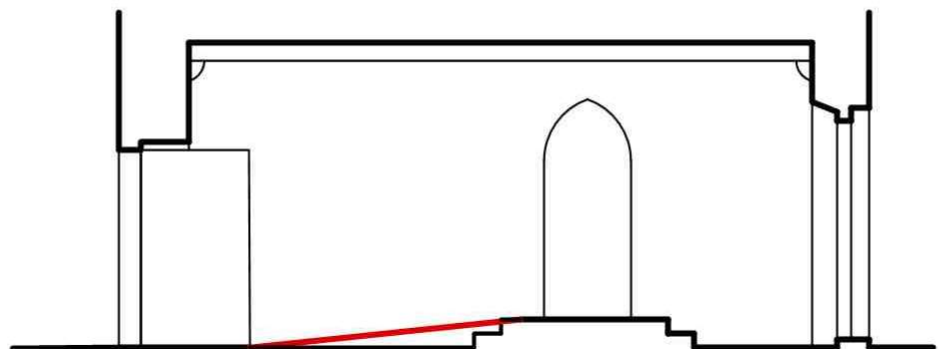
9	South Door Ramp

A 1 in 9.5 ramp from outside the South Aisle south door towards the Vestry west door. NB: This is too steep and so is non-compliant.	Not compliant with Building Regulations. Score = NIL	Not compliant with Building Regulations. Score = NIL	Improvements from South Door down to Accessible WC will be needed, as proposed for many options. Score = MEDIUM	Negligible impact. Score = LOW	Arrival at the west end of the church is suitable. However, the conflict of wheelchair users, visitors and processions at the South Door is significant. Score = LOW	Very modest. Score = LOW	None noted.

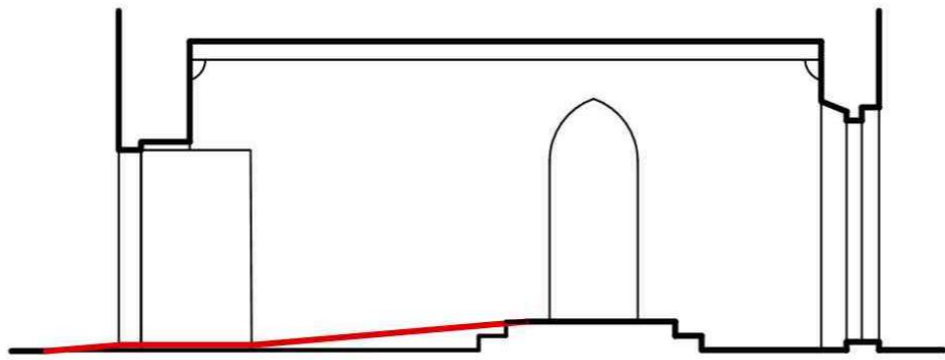
10	South Door Ramps	A 1 in 12 ramp from outside the South Aisle south door towards the Vestry west door. The door threshold would need to be raised as the ramp needs to extend externally also.	Both wheelchair users and able bodied users will be able to use this route, which is only slightly closer to those approaching from the north. There is no space	Both wheelchair users and able bodied users will be able to use this route, which is only slightly closer to those approaching from the north. There is no space for a 1500mm landing clear of the door swing.	Improvements from South Door down to Accessible WC will be needed, as proposed for many options. Score = MEDIUM	Negligible impact. Score = LOW	Arrival at the west end of the church is suitable. However, the conflict of wheelchair users, visitors	Very modest. Score = LOW	None noted.

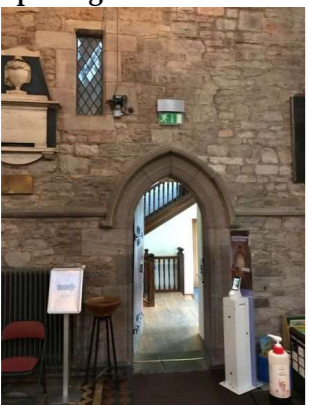
11	South Door enlarged opening

During the event, it was suggested that the conflicts between visitors and clergy/choir processions at the South Aisle south door could be mitigated by widening the door. This option would need to be combined with others to be effective.	Both wheelchair users and able bodied users will be able to use this route, which is only slightly closer to those approaching from the north. Score = MEDIUM	Both wheelchair users and able bodied users will be able to use this route, albeit not side-by-side. Score = MEDIUM	Improvements from South Door down to Accessible WC will be needed, as proposed for many options. Score = MEDIUM	This is a 'modern' C19th door but adjacent masonry is C14th. Loss of fabric would occur. Score = MEDIUM	A wider door would not address the conflict between visitors, processions and those using the WCs. Score = LOW	Additional cost to Option 15 (already scored at HIGH).	Improved connection to Vestry Wing.

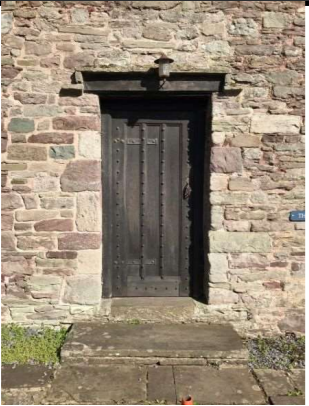
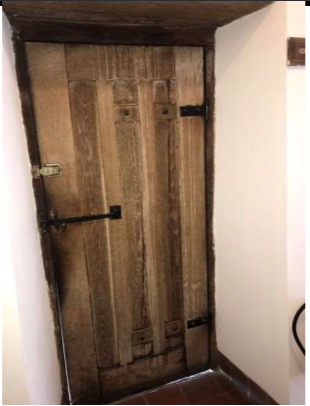
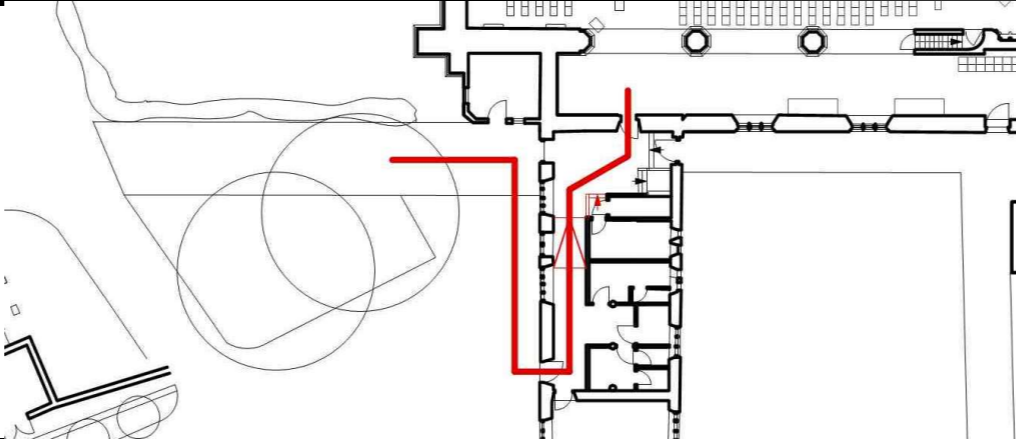
14	Vestry Wing Foyer <i>(Poppy's suggestion)</i> Vestry West Door version	Erection of a new building against the west elevation of the Vestry wing to contain ramped access, assumed to arrive at the Vestry west door, which would be raised to the level of the internal floor of the Cathedral.	Both wheelchair users and able bodied users will be able to use this route, which is only slightly closer to those approaching from the north. Score = MEDIUM	Both wheelchair users and able bodied users will be able to use this route. Score = HIGH	Improvements from South Door down to Accessible WC will be needed, as proposed for many options. Score = MEDIUM	Impact of new structure against grade I Vestry elevation will be high. In addition, raising historic door. Score = HIGH	Arrival at the west end of the church is suitable. However, the conflict of wheelchair users, visitors and processions at the South Door is significant. Score = LOW	Erection of a new building makes this a very expensive option. Score =HIGH	Opportunity to improve welcome for visitors through new build.

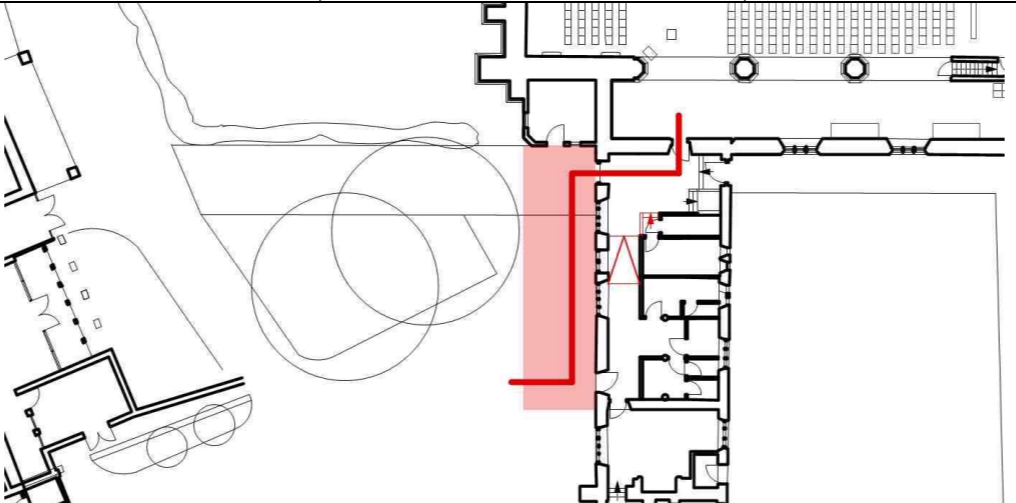
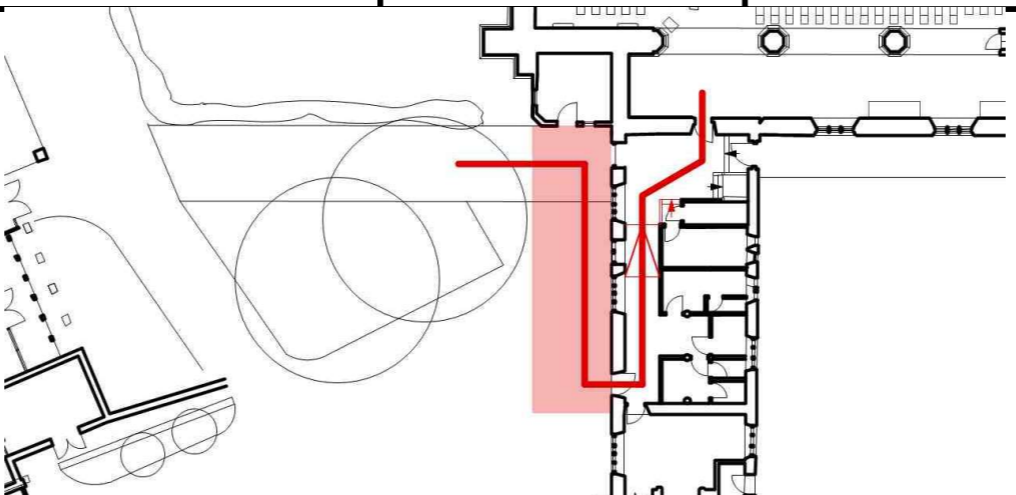
15	Vestry Wing Foyer <i>(Poppy's suggestion)</i> Bishop's Door version	Erection of a new building against the west elevation of the Vestry wing to contain ramped access, assumed to arrive at the Bishop's door.	Both wheelchair users and able bodied users will be able to use this route, which is only slightly closer to those approaching from the north. However it is not an inclusive entrance as most users will use other doors and is a low status doorway. Score = LOW	Both wheelchair users and able bodied users will be able to use this route. However it is not an inclusive entrance as most users will use other doors and is a low status doorway. Score = LOW	Improvements from South Door down to Accessible WC will be needed, as proposed for many options. Score = MEDIUM	Impact of new structure against grade I Vestry elevation will be high. Score = HIGH	Arrival at the west end of the church is suitable, albeit compromised by taking all visitors through a corridor. However, the conflict of wheelchair	Erection of a new building makes this a very expensive option. Score =HIGH	Opportunity to improve welcome for visitors through new build.

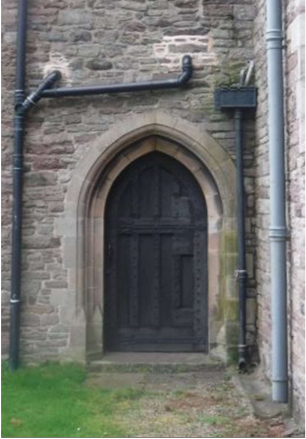
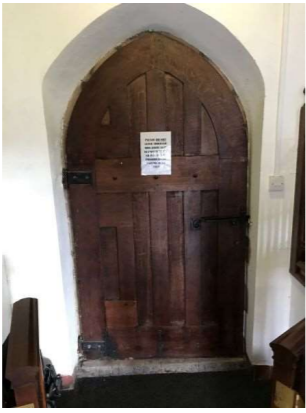
Resurfaced path to angle between Vestry and South Aisle, ramped up to new raised threshold at Cathedral floor level.	No improvement. Score = LOW	Provides access for wheelchair users, but able bodied users would continue to use existing doors, so wheelchair users are separated and use a lesser door. Score = LOW	Improvements from South Door down to Accessible WC will be needed, as proposed for many options. Score = MEDIUM	Impact raising height of existing arch headed doorway. Score = MEDIUM	Arrival at the west end of the church is suitable, albeit compromised by taking all visitors through a corridor. However, the conflict of wheelchair users, visitors and processions at the South Door is significant. Score = LOW	Not insignificant due to length of path and alterations to door. Score = MEDIUM	None noted.

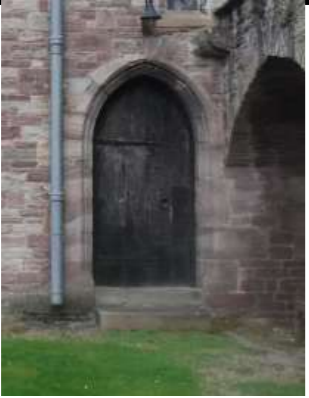
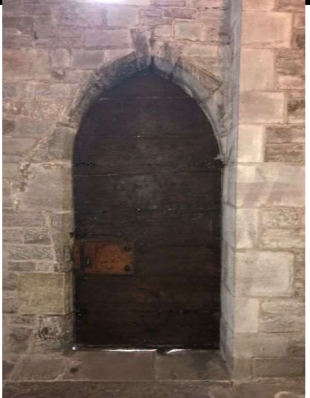
17	South Aisle South East Door	Resurfaced path to South Aisle south east door, ramped up to threshold.	No improvement. Score = LOW	Provides access for wheelchair users, but able bodied users would continue to use existing doors, so wheelchair users	Improvements from South Door down to Accessible WC will be needed, as proposed for many options.	Very minor. Score = LOW	Very poor, as delivers wheelchair users too far	Not insignificant due to length of path.	None noted.
